Curta II serial number 505228 (1954).

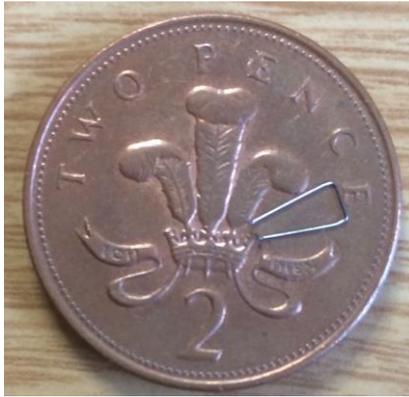
Feather spring on a 2 penny piece. (2'107-3)

I have worked in engineering all my life, but the minute scale of the parts was to say the least, a bit daunting. The first items I made were the feather springs (2'107-4). I obtained some Ø0,20 wire from the internet. After a couple of attempts and losing one that flirited to goodness knows where, I managed to make 2 good springs.

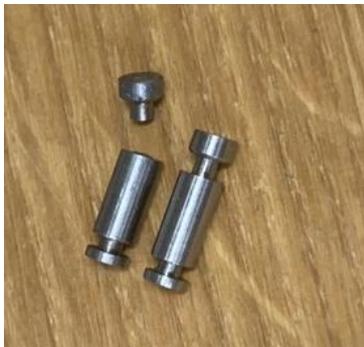
Locking-pin and its replacement. (2'122-1)

The locking pin, which prevents the crank being turned when the carriage is in the raised 'clearing' position was then located in its hole. To do this the crank is turned about 20° and the pin dropped into the hole. This rests on the lower locking washer (2'051-4). The upper carriage assembly is then assembled and rotated until it drops through the cut-out in the upper locking washer. The crank is then rotated until the carriage drops down to its working position.

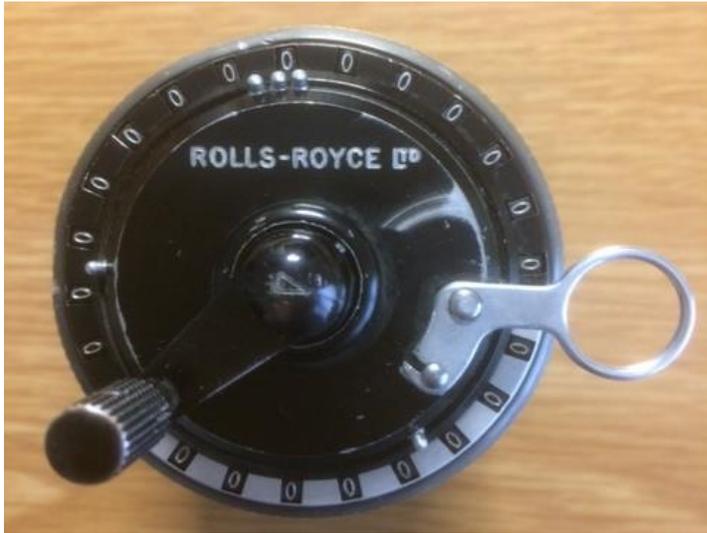
Top view showing the new clearing ring lever.

The rest of the items were kindly made by my son. Fortunately he has a small CNC milling machine and was able to make a very good replacement clearing ring lever.

The broken clearing ring lever (2'154) was removed by filling the end of the rivet away. The replacement was the fitted and riveted into place with a new rivet. The top carriage was then reassembled.

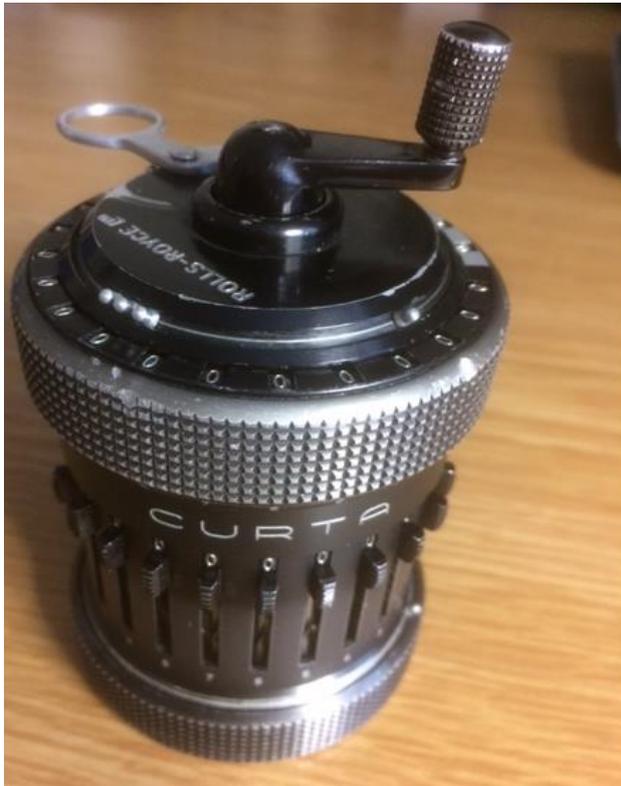
The cosmetic appearance was left in its original condition as I think this tells its own story. As you can see from the photographs, the machine had a very hard life, often being dropped. This calculator was used both on days and nights for over 25 years and is a testament to the original design, in that it survived.

Side view showing some of the battle scars.
